May 20, 1999

AZEEZALY S. JAFFER
MANAGER STAMP SERVICES

SUBJECT: Review of the Printing Error in the
Grand Canyon Stamp (RG-LA-99-001)

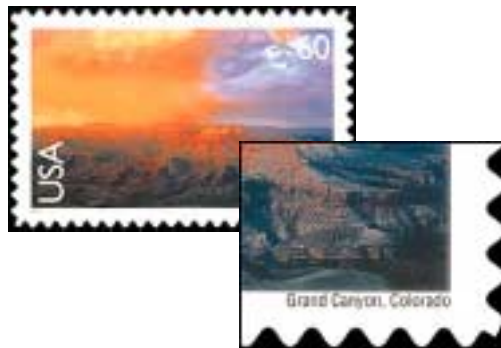
On or about May 11, 1999, Stamp Services staff discovered an error after the stamp was printed while it was been perforated. Specifically, the words "Grand Canyon, Colorado" appeared in the right-bottom corner of the stamp instead of Grand Canyon, Arizona. Beginning May 18, 1999, several national publications including the *USA Today*, *The Washington Post*, and the *Linn's Stamp News* published articles about the stamp error and were critical of the Postal Service's process.

According to Stamp Services officials, Postal Service staff asked the stamp designers to identify the location by adding the words "Grand Canyon, Colorado" to the bottom-right corner of the stamp. Although, the Grand Canyon was created by the Colorado River, the Grand Canyon National Park is located in Arizona.

The stamp had previously been reviewed by the Citizens' Stamp Advisory Committee and by the Postal Service's research consulting firm. However, once the words were added to the stamp, it did not go back to the consulting firm and Postal Service Management for final revisions, which is the established process. Instead, the printer added the words and initiated production. While the stamp was in final printing production, Stamp Services staff noted that the additional wording was incorrect.

We suggest that Stamp Services Management adhere to existing control processes when authorizing changes to the approved stamp design. Specifically, if any subsequent revisions are made, resubmit the revised artwork for approval by Stamp Services staff before production is authorized.
